Streetscape Conditions

Street Illustration - Improvement Concept
EAST SANTA CLARA STREET URBAN VILLAGE MASTER PLAN

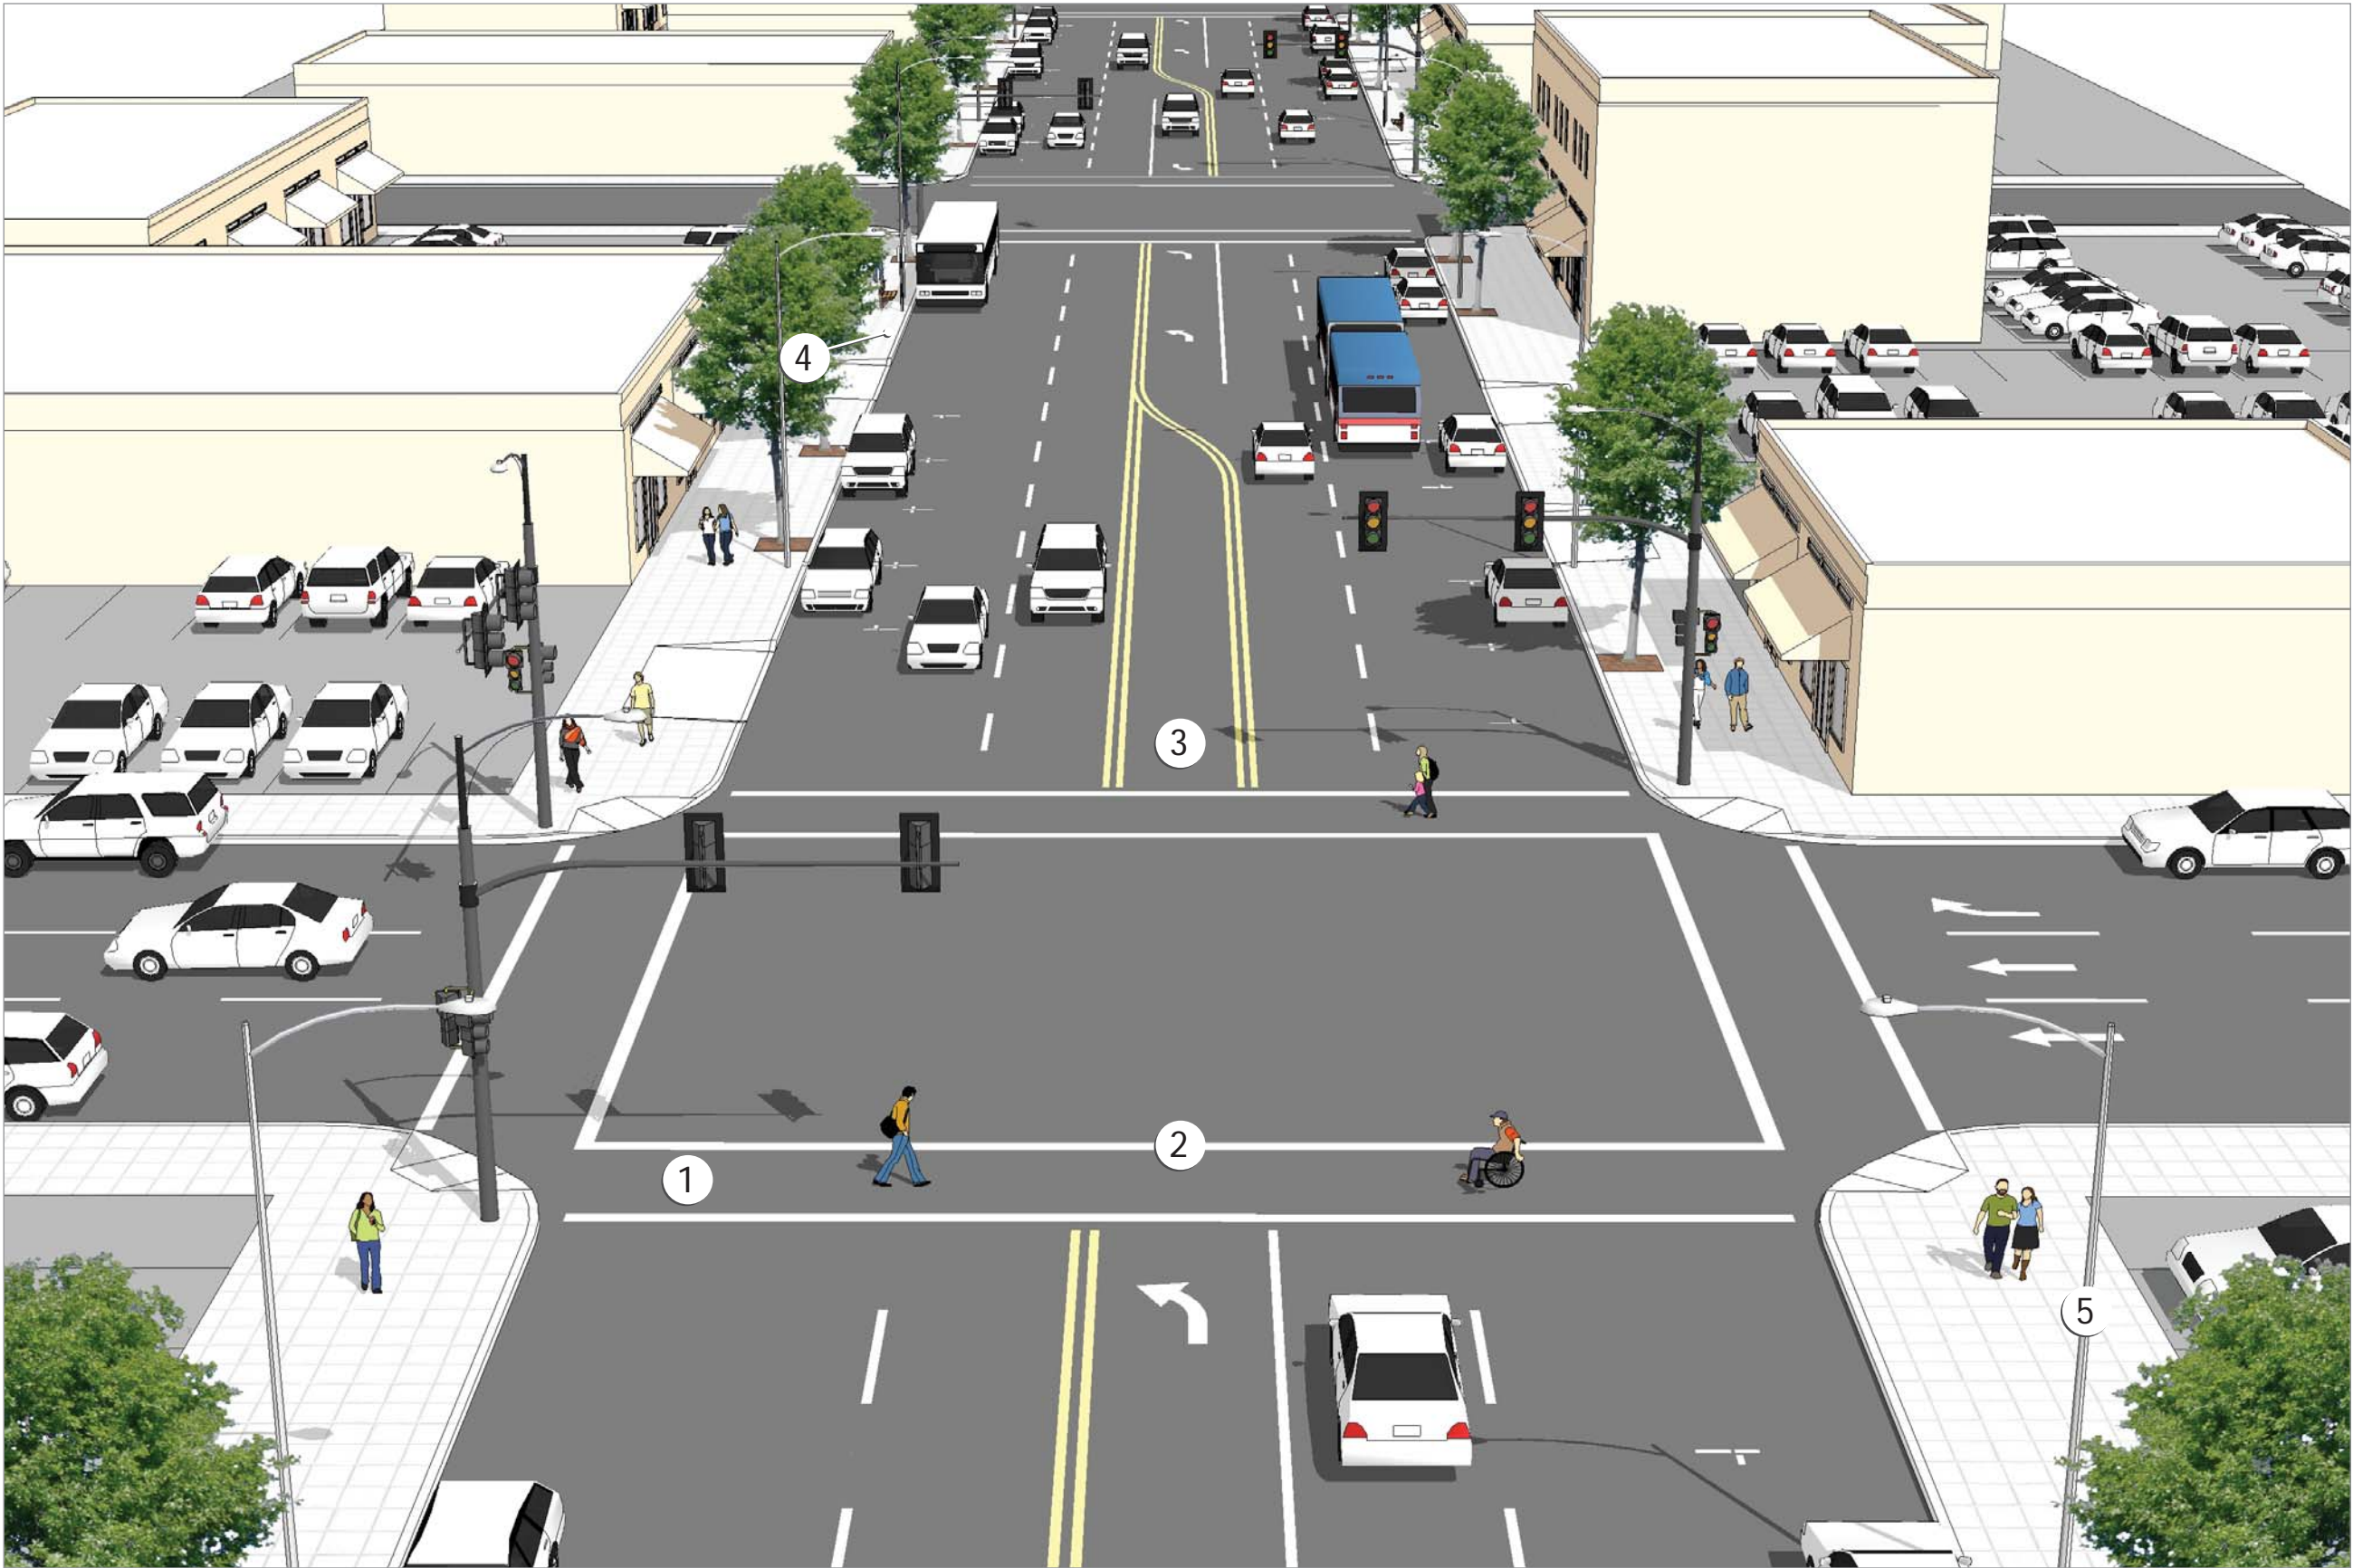
- 1) Long pedestrian crossings (±75')
- 2) Less visible parallel striped crosswalks
- 3) Striped median
- 4) Bus stops lack shelters
- 5) Auto-oriented street light

Street Illustration - Existing

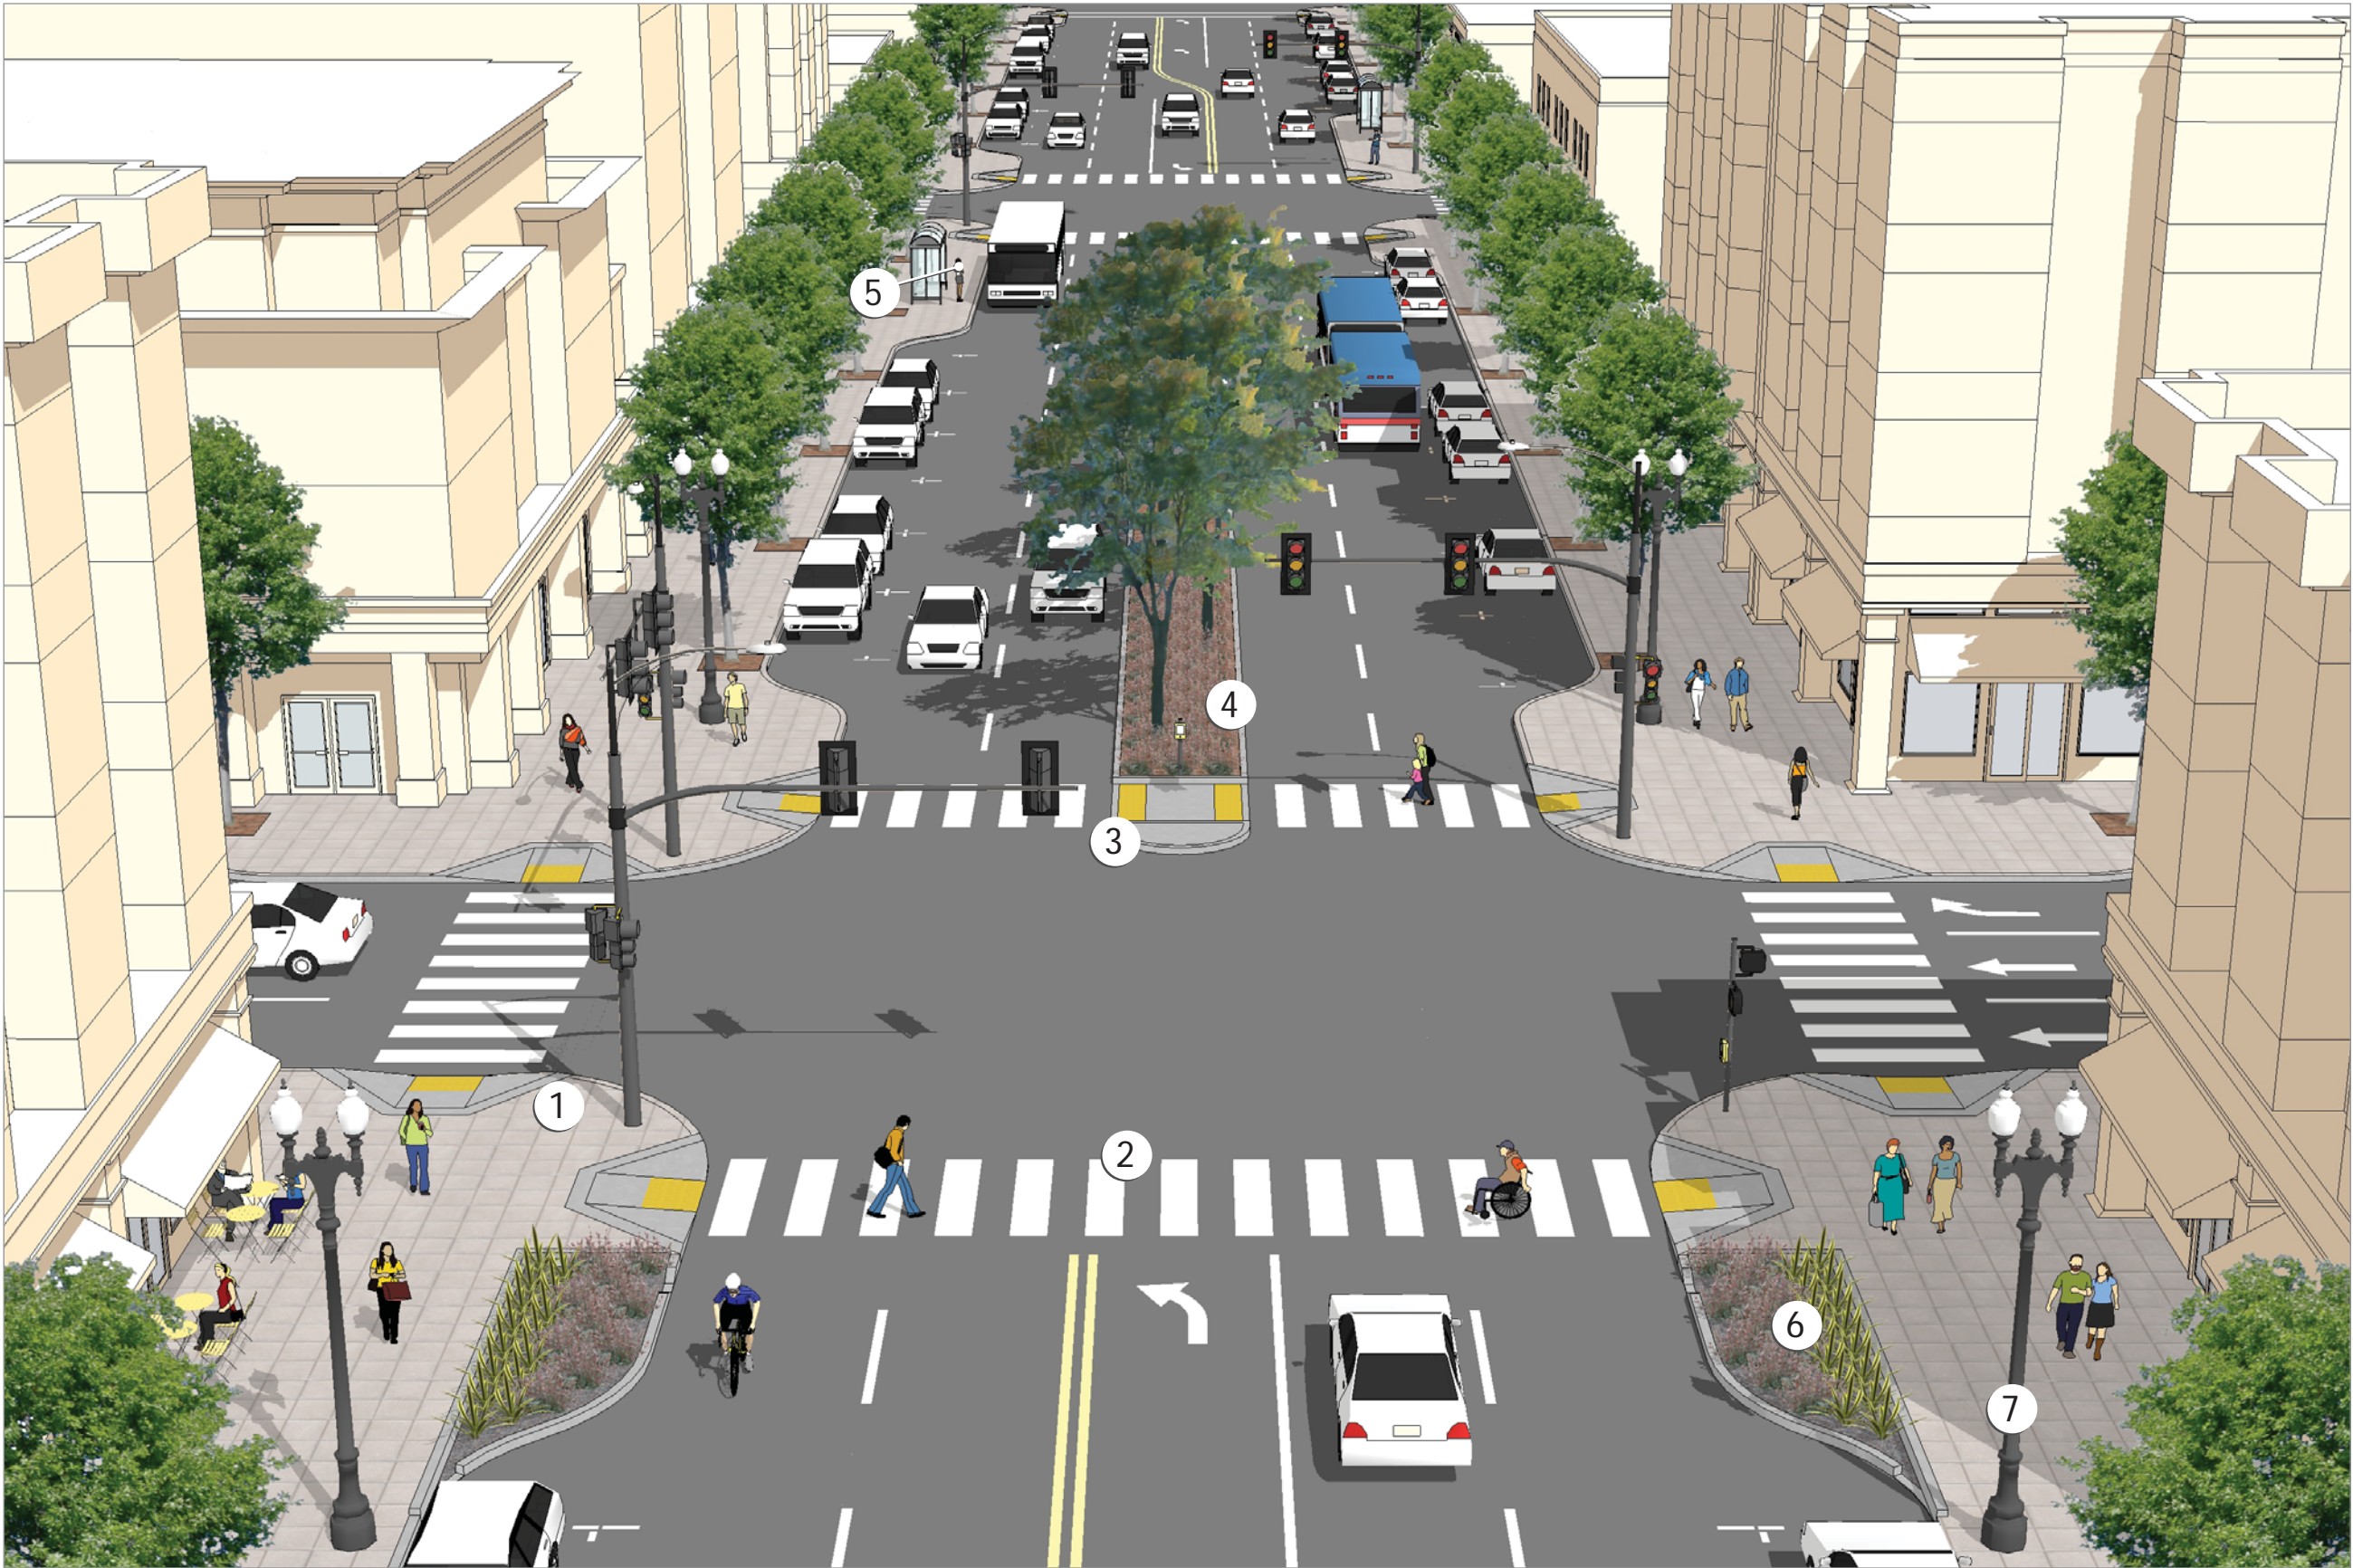
- 1) Bulb-outs shorten pedestrian crossing distances (±55')
- 2) High-visibility crosswalks
- 3) Pedestrian refuge shortens pedestrian crossing distances (±25')
- 4) Planted median replaces striped median where there are no left turn lanes
- 5) Bus stops improved with shelters and bus bulb-outs
- 6) Stormwater infiltration planter
- 7) Pedestrian-oriented street light
